Tellabs® ServiceAssured™ Upgrade for the Tellabs® 8800 Multiserver Router Series

Deliver Continuous System Availability

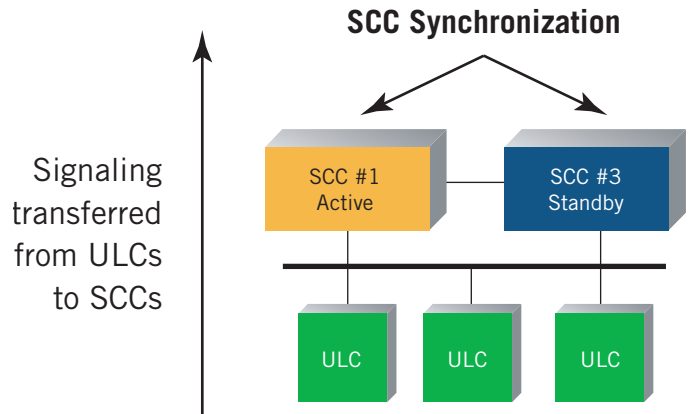
Figure 2. Upgrade SCC #3 and Synchronization

In the execution phase, the first element upgraded is the standby SCC module. By resetting the SCC #3 card (SCC #2 on a Tellabs 8830 MSR) it becomes operational with FP8.0.0.1 software. SCC #3 then synchronizes with SCC #1 by receiving checkpoint data from SCC #1 as shown in Figure 2. During this step, data conversions are done and the configuration files are stored on SCC #3 with the new FP8.0.0.1 database format. This process saves a complete copy of the database in memory on both the active and standby SCC. This enables the operator to revert back to the original mode of operation if desired. The node is no longer fully redundant, and no configuration changes are allowed. Once the synchronization is completed, the configuration file and the database residing on both SCCs are identical.

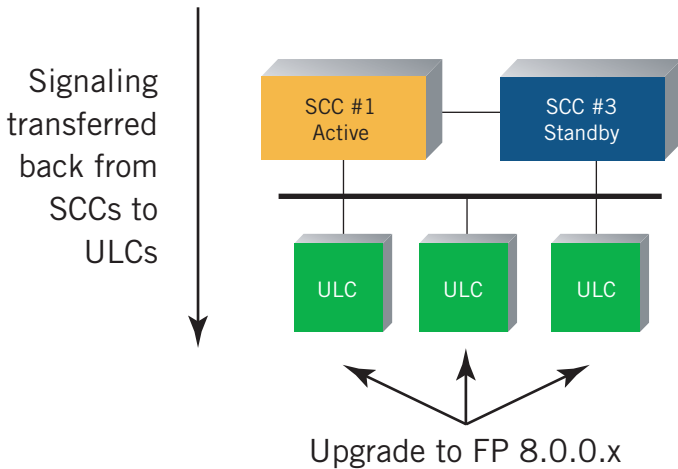
The ULCs are then upgraded to FP8.0.0.x through a soft reset as shown in Figure 3. By transferring the signaling function to the SCC, the Tellabs ServiceAssured Upgrade prevents a soft reset of the ULC due to signaling errors and an eventual link failure report by a remote node. Each ULC reloads the FP8.0.0.x software from RAM, which minimizes the startup time for the ULCs. ULCs do not write to hardware as traffic continues to be forwarded. All Layer 2 and Layer 3 sessions such as LSPs, OSPF, IS-IS are fully maintained by SCC #1 during the reload. The ULCs replay connection information from the active SCC and create a RAM image, but do not write to the hardware at this point.

After all of the ULCs completely reload, they rewrite all of the hardware (PP, PM, PS, CAM) at once to match the reloaded configuration. The signaling on the SCC is also suspended. The process is synchronized so that connections, microcode and CAM entries across all ULCs are from the same FP8.0.0.x version before activating the traffic flow again. During this rewrite step, there is a short period (<2.5 seconds) where traffic forwarding halts while the hardware reinitializes.

Figure 3. Upgrade all ULCs to FP8.0.0.x

Once all the connections, microcode and CAM entries are synchronized across all the ULCs, signaling functionality is returned to the ULCs.

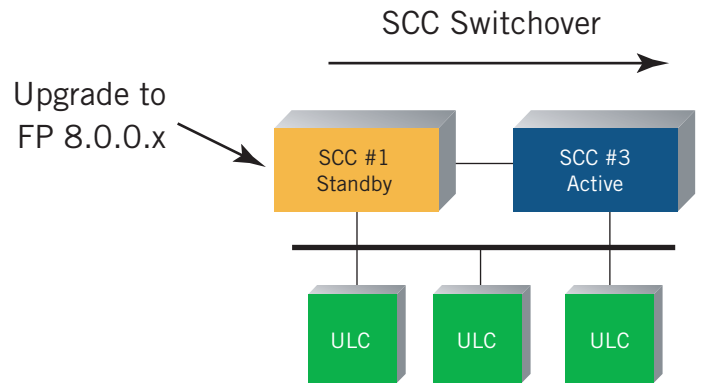
The node now performs an SCC switchover as shown in Figure 4, where SCC #3 running the target software becomes active and node isolation ends. SCC #1 is reset and reloaded with the target software and becomes the new standby after synchronizing with the active SCC. The node is now fully redundant and operational with the target software version.

Figure 4. Fully redundant with FP8.0.0.x

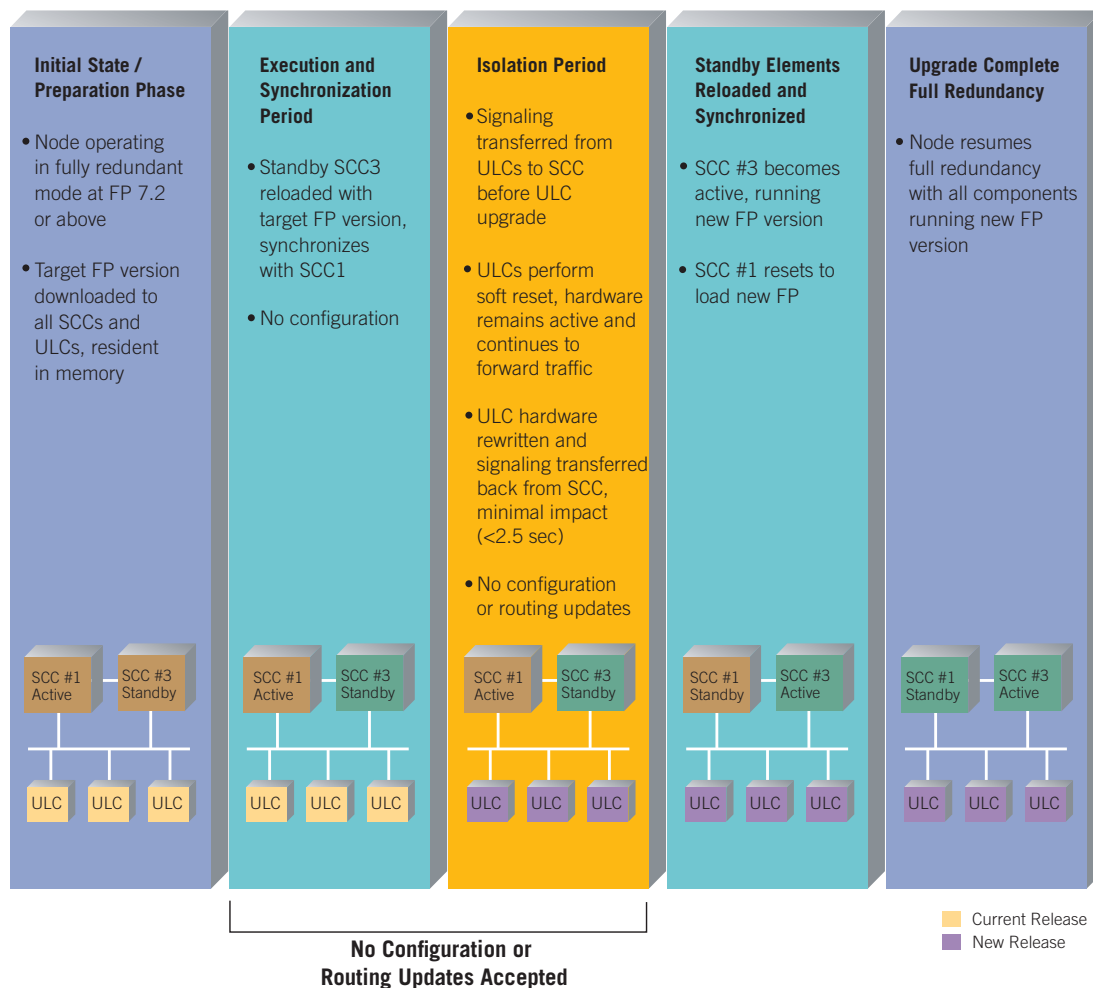
The entire Tellabs ServiceAssured Upgrade process is shown with the timing diagram in Figure 5. Prior to the preparation phase, the SCCs and ULCs are loaded with the target FP8.0.0.x software. During the preparation phase, the system undertakes internal checks and verifications to assure that the software upgrade is successful. The node is checked to make sure that it is fully functional and completely redundant. The operator then issues an “enable config node upgrade” command to initiate the SCC reset.

Figure 5. Tellabs ServiceAssured Upgrade Summary

At this stage, the system is no longer fully redundant. Once the standby SCC recovers and is operational with FP8.0.0.x, the user is prompted before entering the isolation phase. Prior to entering the isolation phase, any abort or failure reverts the node to the old software (FP7.2.1.6) with no effect on network traffic.

If the user decides to proceed with the upgrade, the node enters the isolation mode. During the isolation phase, signaling is first transferred from the ULCs to the active SCC. The ULCs then reload and the SCC performs a final switchover. The hardware on the ULCs is reprogrammed during this period.

It is important to note that upon initiating a standby SCC reset before the time the node exits the isolation period, no configuration changes or routing updates are accepted. During the isolation phase, an abort or failure reverts to old software only through a node reset. The purpose of having the isolation mode is to assure that the upgrade sequence proceeds successfully without any external interruptions (i.e. configuration changes).

Once the system leaves the isolation phase, the upgrade is complete and the standby elements are reloaded and synchronized with the active elements. The node at the completion of this stage is fully redundant and operational.
